Monitoring of Nutrient and Sediment Loading from Construction Sites

North Carolina's Section 319 NPS Program
NC DENR – Division of Water Quality
DWQ Contract Number: EW05015

Richard A. McLaughlin, Ph.D.
Associate Professor
Soil Science Department

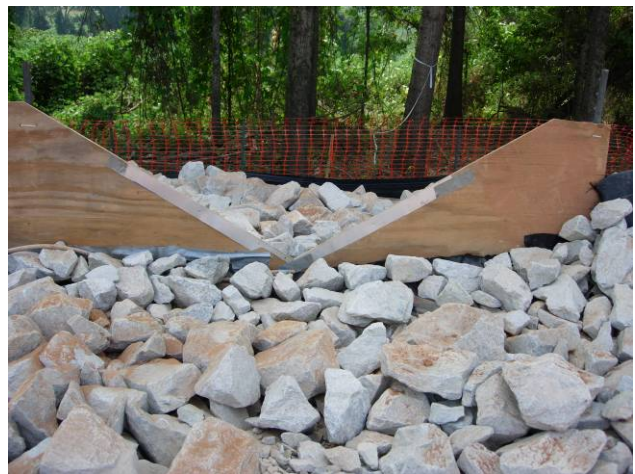
Figure 3. Weir used at Site WAKE2.

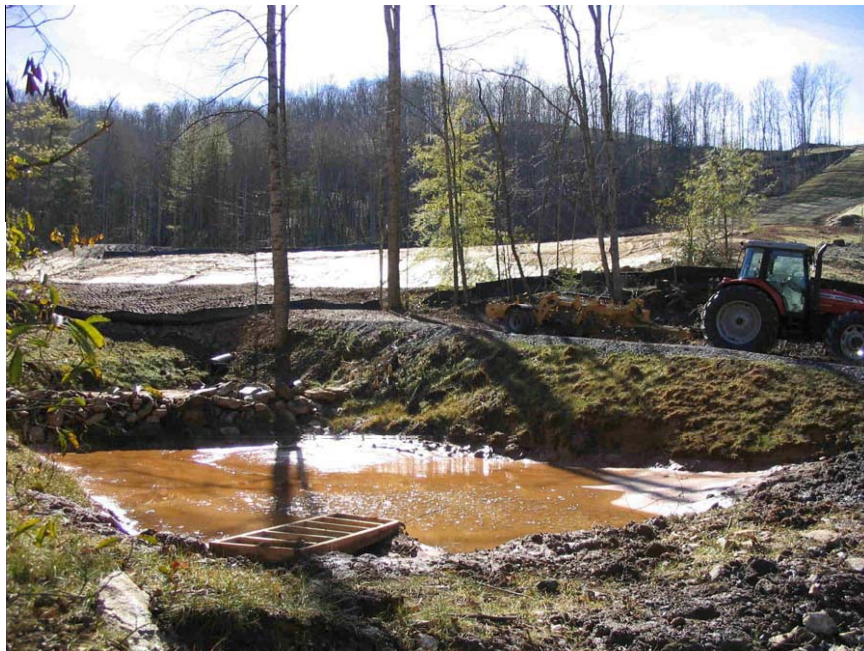
Figure 4. The upslope drainage area at Site JACK.

The upslope disturbed drainage area was approximately 8 acres in size and quite steep with an average slope of about 25%, though portions of the site varied between 20-30% slopes. The area was almost entirely bare at the start of the monitoring period and was slowly revegetated in turfgrass as the various stages of grading for the project were completed.

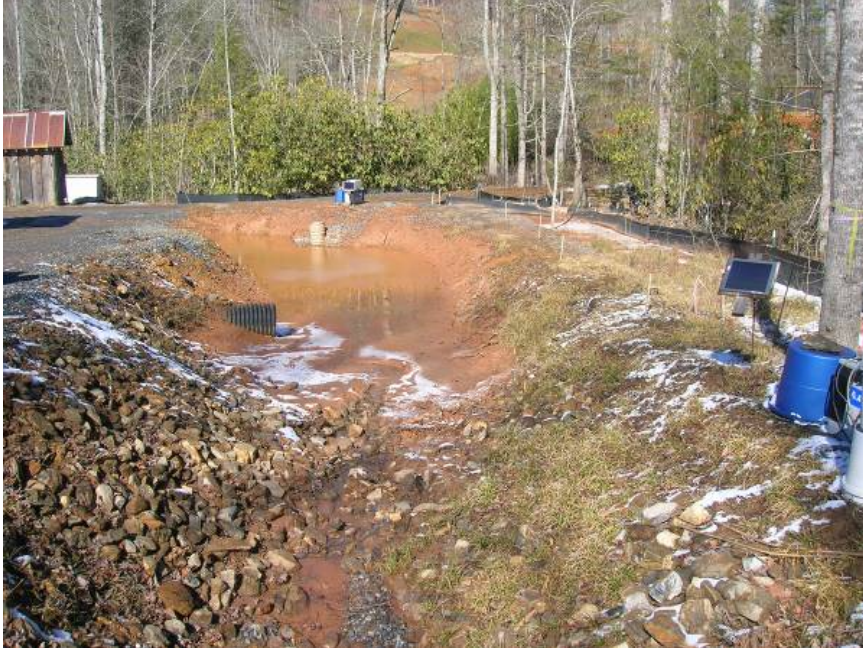
Figure 5. The sediment basin and samplers at Site JACK.

This site was one phase of a large golf course and residential development that had a single sediment basin (approximately 60' long by 20' wide by 4' deep) with a rock-lined inlet channel and an 18" perforated riser pipe outfall surrounded with gravel (Figures 4 and 5). The sideslopes of the basin were poorly vegetated. A wooden weir and sampler were installed in the inlet channel to collect entrance flow data and water samples, while a sampler alone was placed at the outfall. The weir wasn't installed until June of 2006 and so only the final five storm events had flow data measurements collected. Basin discharge flow volumes were estimated for those storms by subtracting the basin volume from the known total inflow volume. While not taking into account basin volume changes from sedimentation or infiltration, this does provide a rough 'worst-case' estimate of sediment and nutrient discharge off site.

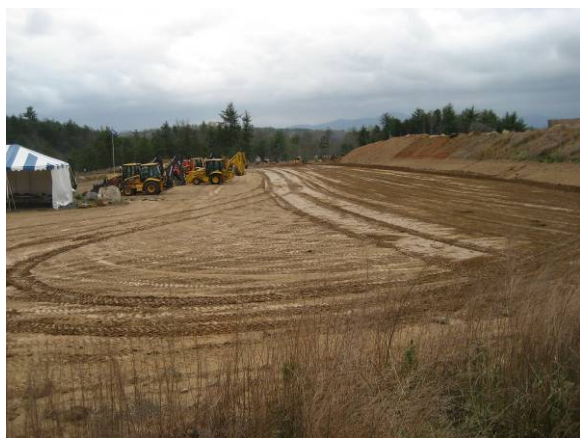
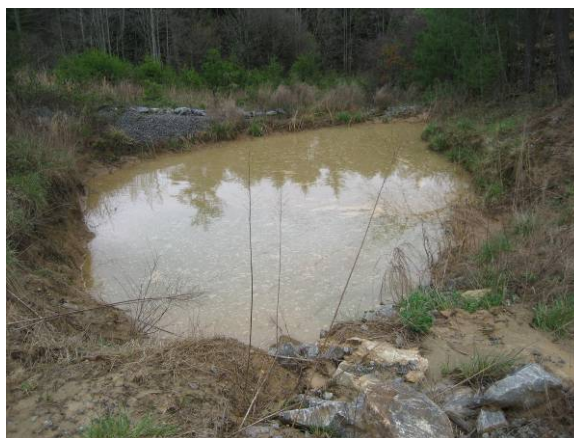
Figures 6 and 7. The disturbed area upslope and the sediment basin at Site BUNC.

This site was a construction vehicle testing facility and had an oval-shaped sediment basin 50' long by 25' wide by 3' deep with an 18" metal pipe inlet and a rock spillway outlet (Figures 6 and 7). There were neither baffles nor a skimmer device installed and the sideslopes, while not steep, were poorly stabilized and significant rill formation was observed over the monitoring period. Samplers were installed with intakes at a weir in the inlet pipe and at the rock outlet. Flows were measured in the weir.

The basin drained a flat (1% slope) 14 acre disturbed area that was used as the testing grounds. The traffic kept the area continuously disturbed with a rough bare surface throughout. The basin was not well maintained and we abandoned the site in March 2008 when the basin filled in from a large storm and no plans by the owner to remove the sediment. Only six storm events produced discharges over the 7 months of monitoring, due largely to the severe drought during the monitoring period.

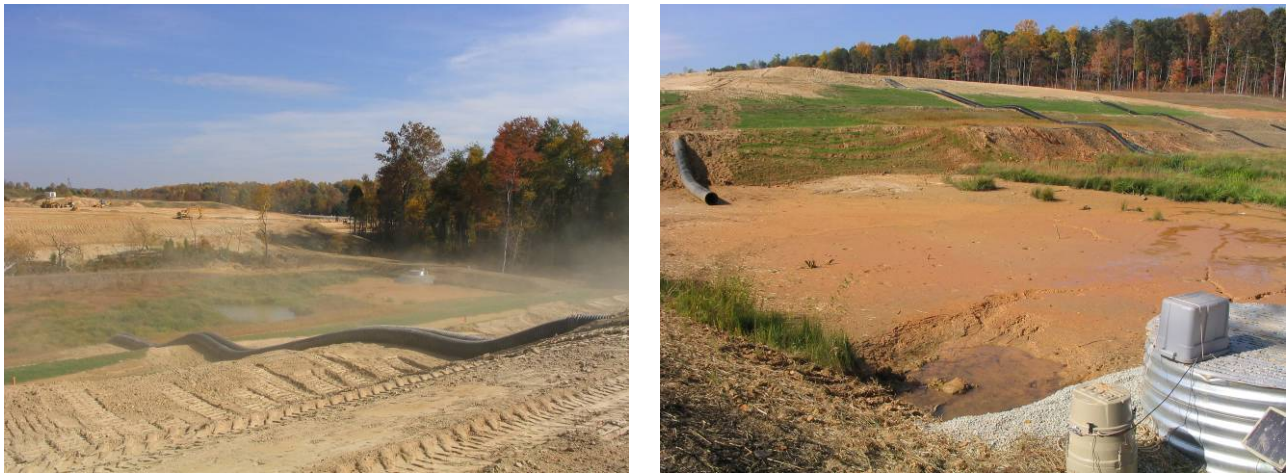
Figures 8 and 9. The disturbed area upslope and the sediment basin at Site GUIL.

This site was an airport runway construction project consisting of two phases of monitoring, each distinguished by both the size of the disturbed drainage area and by the size of the sediment basin. During phase 1, the basin was about 300' long by 100' wide by 5' deep and had an approximate 75 acre drainage (Figures 8 and 9), while in phase 2 the basin was substantially filled-in to make it 50' long by 100' wide (about an 80% reduction in size) and with a reduced drainage area of 35 acres. At times during both phases, runoff from the flat (<1% slope) disturbed area adjacent to the basin was conveyed into the basin in plastic slope drains, though they frequently failed or were bypassed, eroding rills into the basin sides. Samples for the entrance to the basin were obtained either in a slope drain, or, once the erosion around them occurred, on a stake in the upper end of the basin. The basin itself had steep sideslopes that never established much in the way of vegetation. The outlet consisted of a large 72" perforated metal riser barrel with a gravel collar (Figure 8), which discharged water out of the basin in a 36" metal pipe. This discharge pipe was where a sampler was placed to measure flow and collect exit samples.

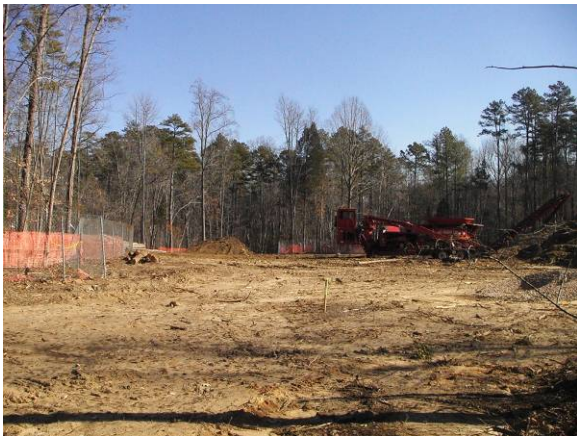
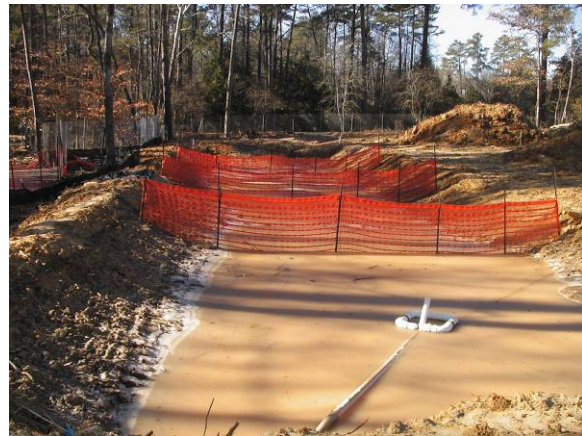
Figures 10 and 11. The disturbed area upslope and the sediment basin at Site ORAN.

This site was an educational facility construction project that had a sediment basin (60' long by 15' wide by 3' deep) with three porous baffles made of plastic tree protection fence and both a rock spillway and a 2" diameter skimmer dewatering device (Figures 10 and 11). There was one designed inlet to the basin, though it was not stabilized and eroded significantly during the sampling period. The basin sidewalls were fairly steep and were not stabilized until rills had already begun to form, at which point the jute matting placed along the slopes was ineffective. The rills that formed got progressively worse and no doubt contributed to an increase in sediment in the basin. Unfortunately, a second inlet channel eroded into the sidewall near the skimmer drain, where a large volume of sediment was deposited, despite attempts to stabilize it with geotextile matting.

The drainage area was approximately 0.9 acres with a 5% slope. It had been a mature pine forest until cleared, and it was continually disturbed throughout the sampling period. The perimeter of the basin was heavily covered with wood mulch made from trees ground up on site.

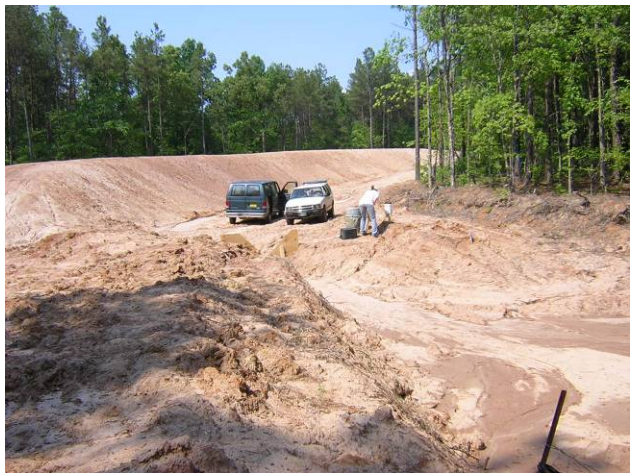
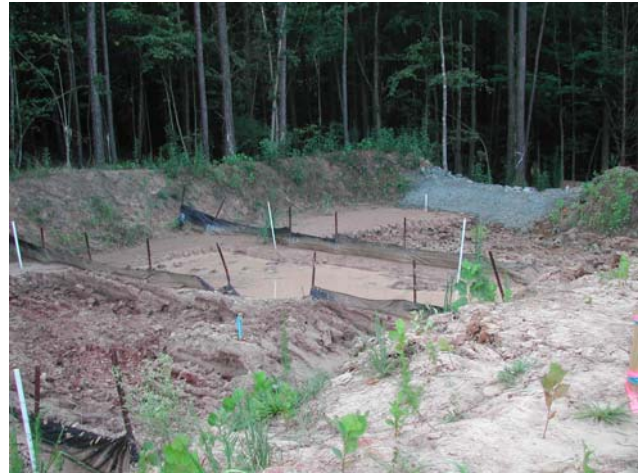
Figures 12 and 13. The upslope disturbed area and sediment basin at Site DURH. The photo on the right shows an attempt at maintenance, with a small amount of sediment removed and a new rock dam.

This residential development had a sediment trap approximately 70' long by 35' wide by 3' deep with silt fence baffles (Figures 12 and 13). The outlet for this trap was a 15' wide rock dam comprised of gravel layered on larger stone. As it was a trap and not a basin, meaning it had a rock dam outlet, runoff flowed directly out the dam at the back of the trap. The basin had 2:1 sloping sidewalls that were initially seeded and covered with straw, but vegetation was not well established (Figure 13) and eroded during the monitoring period. A rectangular weir with end contractions was installed on the back side of the rock weir, where a sampler with bubbler module was installed to measure flow and collect samples. An attempt was made to install a wooden weir in the large inlet channel as well, but the channel experienced so much flow bypass and was quickly and consistently buried in sediment during each storm that little useful data was collected here.

The site had a 1.5 acre disturbed drainage area at an approximate 5% slope which was continually disturbed throughout the project, resulting in large sediment loads coming into the trap.

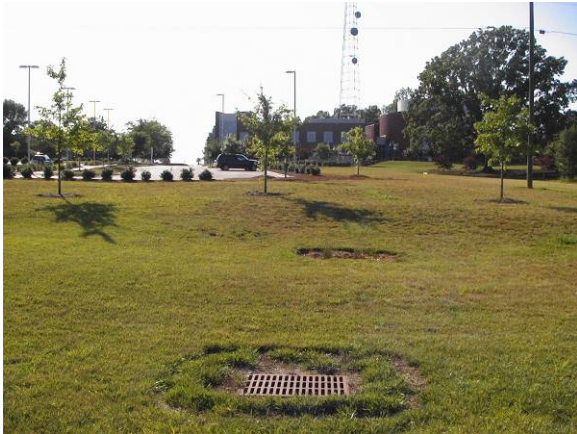
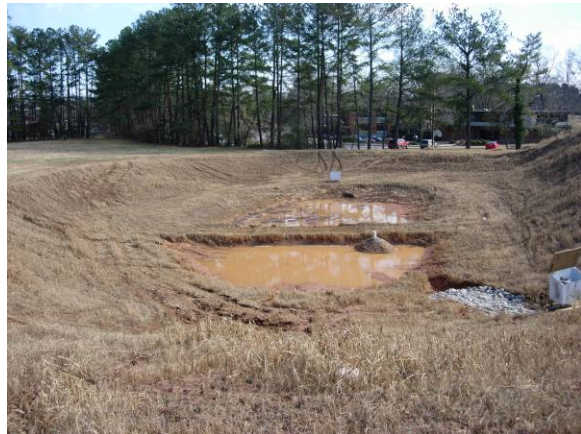
Figures 14 and 15. The drainage area (current condition) and the sediment basin at Site WAKE1.

This site was an educational facility construction project that had a large oval-shaped sediment basin approximately 150' long and 100' wide with a rock-stabilized inlet channel and a concrete culvert outlet (Figures 14 and 15). The sidewalls were steep but well vegetated with little rill formation observed. The basin was converted into a general stormwater basin upon project completion and as a result was slightly more complex in design than most temporary sediment basins. It had two separate, 2' deep chambers connected by a perforated riser pipe with a gravel collar. Sampling was done at a weir installed in the rock inlet channel and in the culvert outlet, allowing flow to be calculated for both the basin entrance and exit.

The drainage area was approximately 5.5 acres at an average slope of about 2% and included the construction area, a hard-packed gravel parking lot, and a small, vegetated field. The entire area immediately adjacent to the basin was established turfgrass, which acted as a buffer filter for the runoff entering the basin from sources other than the inlet channel. Unfortunately after several storm runoff events, including one observed in the field, it was concluded that this entire area was not fully draining into the basin as was designed in the project plans. Some of the construction site runoff was apparently flowing into the drainage ditch of a nearby road. Since the basin was very non-standard in design and essentially oversized due to the diversions of construction site flow to the road ditch, we moved to another site.

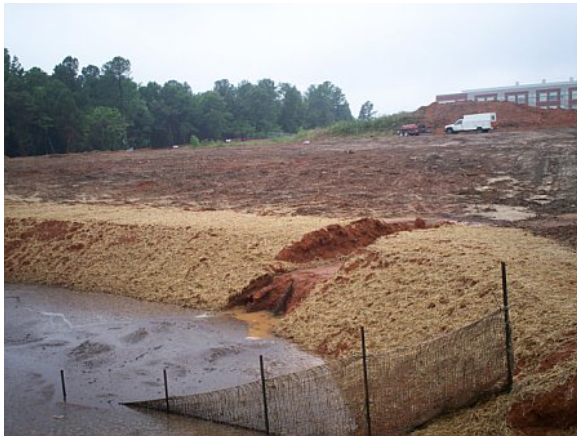
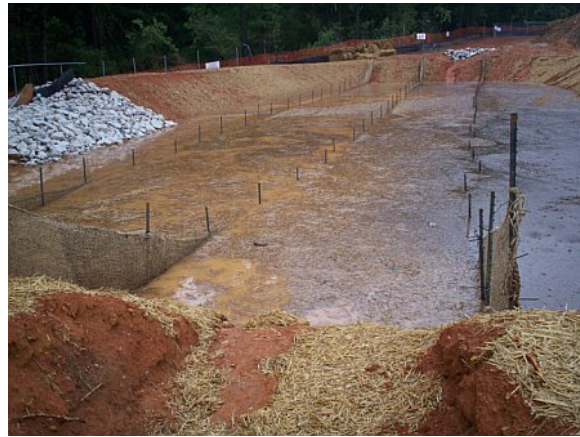
Figures 16 and 17. The disturbed area upslope and the sediment basin at Site WAKE2.

This site was an educational facility construction project that had a large rectangular basin (80' long by 30' wide by 5' deep) with a solid dam (surface) spillway (Figures 16 and 17). Three rows of baffles made of thin jute netting were also installed in the basin. The sidewalls were fairly steep though the contractor did seed and straw with mixed success at establishing vegetation. As a result, rill formation was observed and two significantly large channels quickly eroded into the sidewalls. A wooden rectangular weir was installed in the rock spillway along with a sampler, but multiple inlets precluded monitoring water entering the basin.

The upslope disturbed area was approximately 3 acres in size at an average 11% slope initially, although this was drastically changed over time. This area was worked and graded throughout the entire sampling period resulting in a continually disturbed soil surface that generated very turbid standing water in the basin. Geese were also observed on a few occasions in and around the basin, so there was a potential for impacts from waste deposits. Unfortunately, due to both the size of the basin and the extraordinary drought experienced in the region during the monitoring period, only 1 storm event resulted in any overflow.

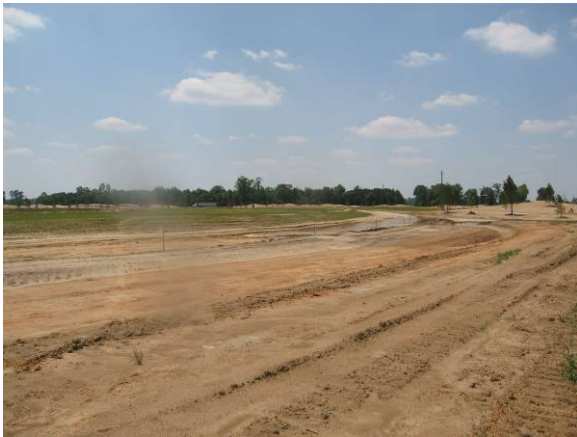
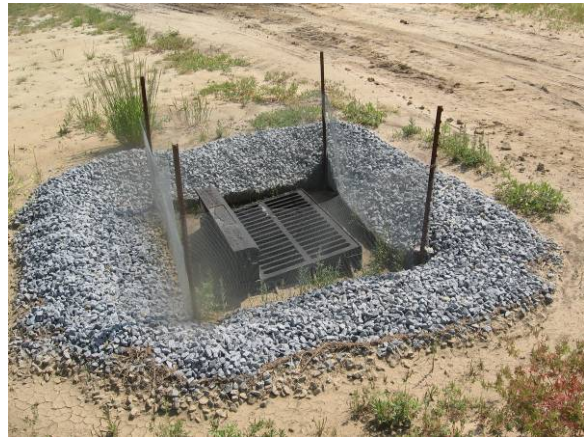
Figures 18 and 19. The disturbed area upslope and an example inlet structure at Site GREE.

This site was a large residential development with a large basin (500' long by 150' wide by 11' deep) with a concrete riser outlet at an elevation 3' above the floor of the basin (Figures 18-21). The outlet had a 6" diameter skimmer dewatering device attached as well. The sides were 4:1 slopes and were quickly stabilized with vegetation, except for a small section by the outlet. As a result, there was very little erosion on the basin slopes. The basin drained a 51 acre disturbed area with multiple drop inlet structures that fed into two 4' diameter concrete culverts. These emptied into the basin at opposite corners from the outlet. The surrounding drainage area had an estimated 0.5% slope and was initially completely bare. Sporadic seeding efforts were attempted in some parts of the drainage as grading was completed, but low rainfall during the period prevented a successful establishment. Samplers were installed at the skimmer outlet and in each of the two inlet drain pipes in order to obtain flow and water quality data at the inlet and outlet.

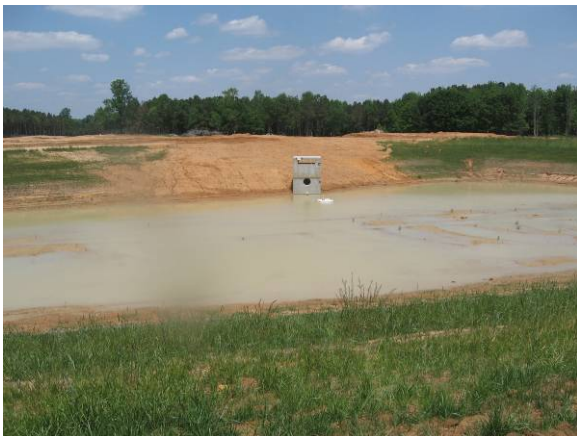
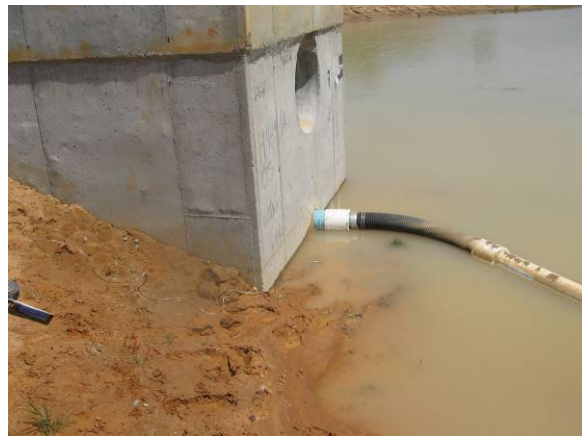
Figures 20 and 21. The large sediment basin and concrete riser outlet with skimmer.
